Manhole Inspection Summary

Manhole # S31U1_004MH

Insp Date: **5/6/08 11:05 AM**

Location Address: **601 W. Patapsco Ave.**

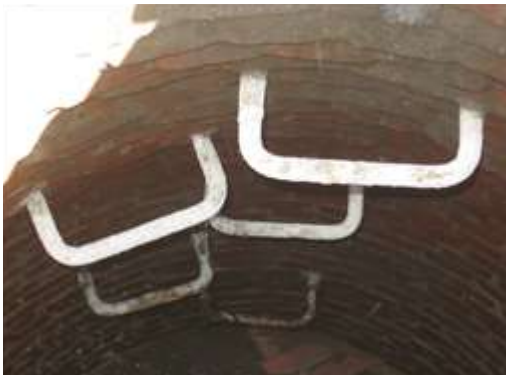
Steps Count: **5** Missing: **0** ☒ **Corroded**

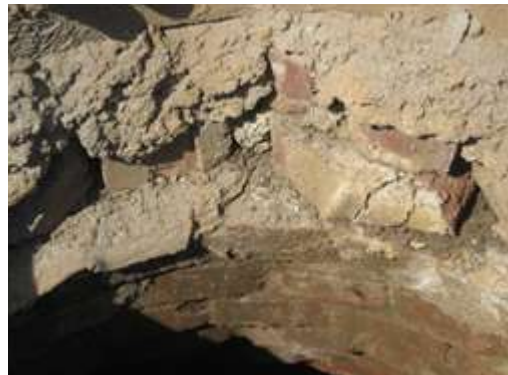
Defect 2

Frame Offset: **3.5** (in.) Condition: ☒ Sound ☐ Cracked ☐ Leaks

Frame offset

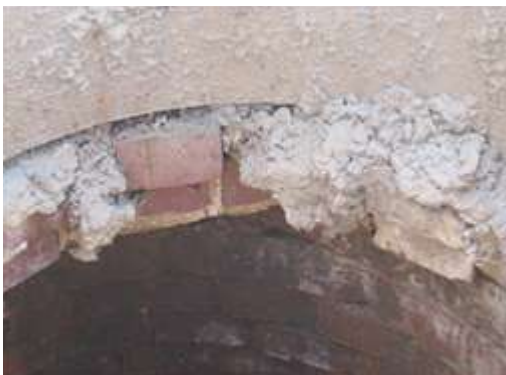
Defect 1

Condition: ☐ Sound ☐ Cracked ☐ Root Intrusion ☒ **Loose Brick** ☐ Deteriorated

Infiltration: ☐ None ☐ Joint ☐ Cracks ☒ **Mortar** ☐ Roots ☒ **Wall**

Mortar infiltration

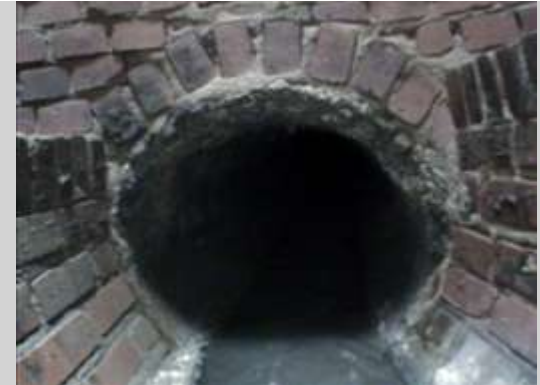
12 O'Clock Outflow

21 in. Circular Gravity Sewer
Pipe Out @ 12 O'Clock

Pipe Height: **22.8** (in.) Rod and Bar (Angled)
Pipe Material: **Concrete** ☐ Pipe Lined
Invert Depth: **11.56** (ft.) Flow Characteristics: **Fast**
Deposits: ☒ None ☐ Mud ☐ Sludge ☐ Debris ☐ Grease
Silt Depth: (in.) Deposits Extent:
Infiltration: **None** Pipe Seal Cond: **Sound**

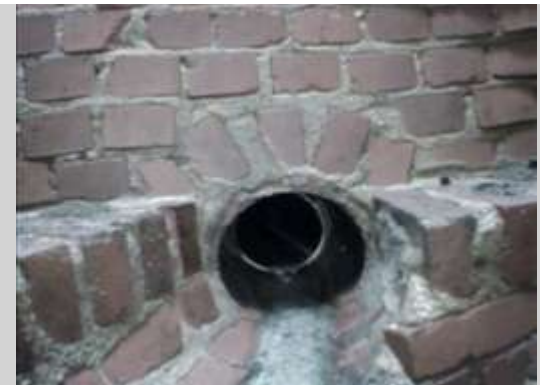
5 O'Clock Inflow

10 in. Circular Service Sewer
Pipe In @ 5 O'Clock

Pipe Height: **9.6** (in.) Rod and Bar (Angled)
Pipe Material: **Clay** ☐ Pipe Lined
Invert Depth: **10.08** (ft.) Flow Characteristics: **Fast**
Deposits: ☒ None ☐ Mud ☐ Sludge ☐ Debris ☐ Grease
Silt Depth: (in.) Deposits Extent:
Infiltration: **None** Pipe Seal Cond: **Sound**

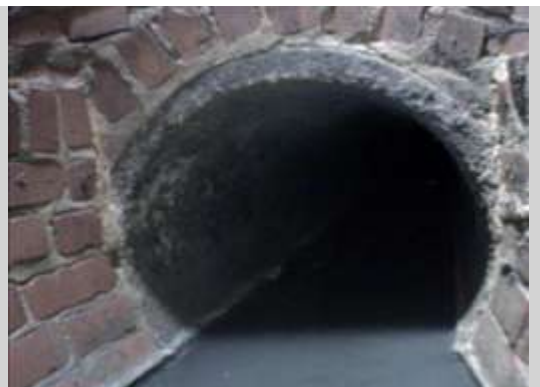
7 O'Clock Inflow

21 in. Circular Gravity Sewer
Pipe In @ 7 O'Clock

Invert Depth: **11.38** (ft.) Flow Characteristics: **Slow**

Infiltration: **None** Pipe Seal Cond: **Sound**
